Manhole Inspection Summary

Manhole # S31II_003MH

Location Address: **1407 LAFAYETTE AVE**

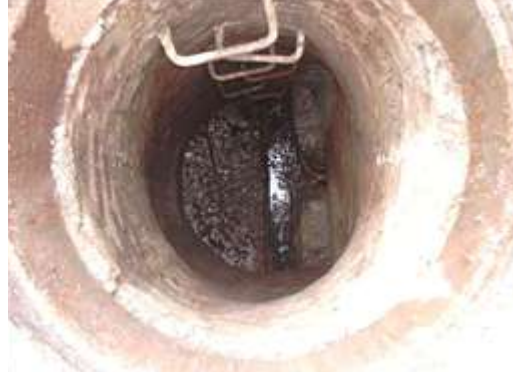
Top View

Corroded steps. Bench and Channel debris.

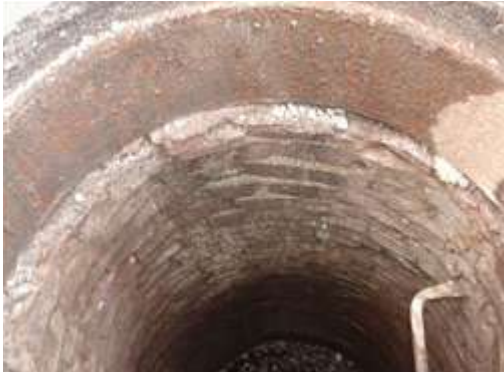
Defect

Frame leaks. Adjustment deterioration and infiltration. Corbel and Barrel infiltration - other side.

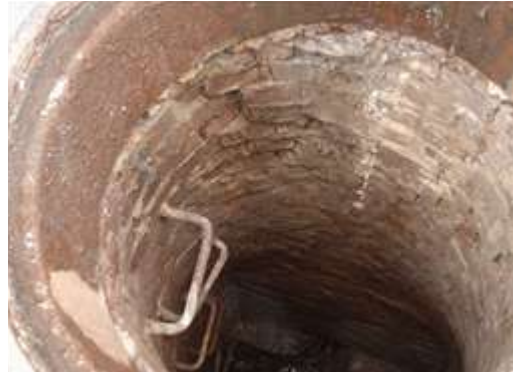
Defect

Frame leaks. Adjustment deterioration and infiltration. Corbel and Barrel infiltration.

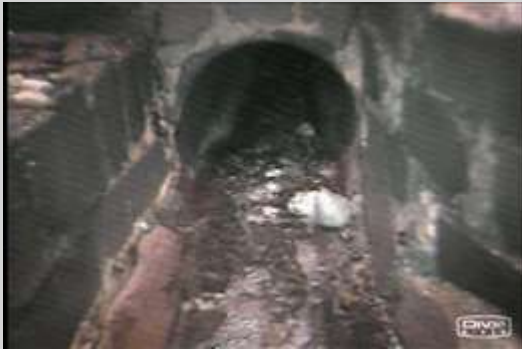
8 in. Circular Gravity Sewer Pipe Out @ 12 O'Clock

Deposits: ☐ None ☒ **Mud** ☐ Sludge ☒ **Debris** ☒ **Grease**

Silt Depth: **0.5** (in.) Deposits Extent: **Light**

Infiltration: **Evidence** Pipe Seal Cond: **Unknown**

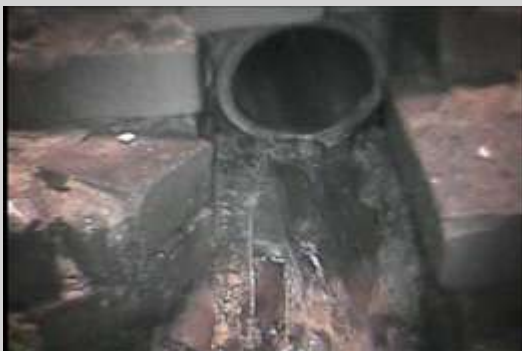
6 in. Circular Gravity Sewer Pipe In @ 3 O'Clock

Channel deterioration.

Infiltration: **Evidence** Pipe Seal Cond: **Broken**

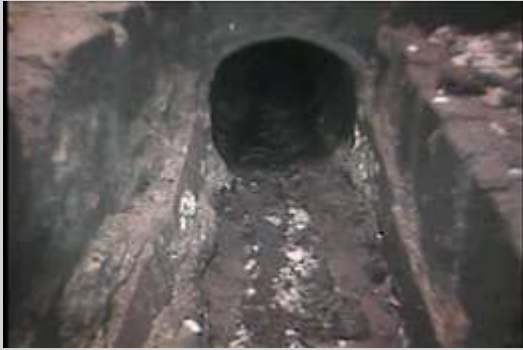
8 in. Circular Gravity Sewer

Deposits: ☐ None ☒ **Mud** ☐ Sludge ☒ **Debris** ☐ Grease

Silt Depth: **1** (in.)
